# Out of place cylinders discovered in the postoperative period

Steven K. Wilson<sup>1</sup> · Justin Parker<sup>2</sup> · Rafael Carrion<sup>2</sup> · Jay Simhan<sup>3</sup>

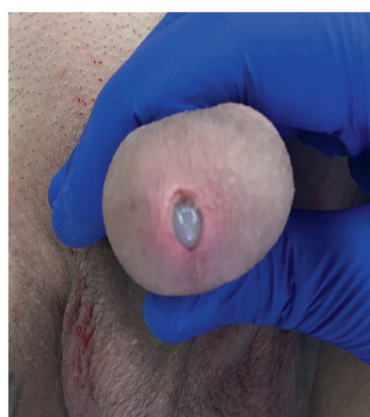
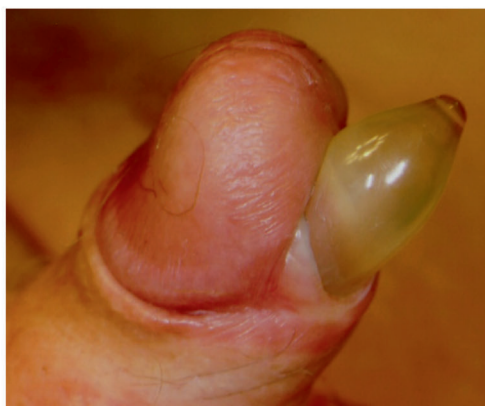
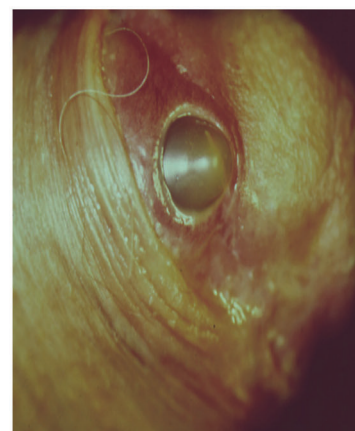
A. Erosion into urethra

B. Erosion through penile skin

C. Infection erosion through glans hyperemia &amp; purulent drainage

**Fig. 1 Erosion of cylinders.** **a** Erosion into urethra. **b** Erosion through penile skin. **c** Infection erosion through glans hyperemia & purulent drainage.

It is imperative to address impending cylinder erosion since, if left unchecked, it is inevitable the cylinder will erode through the tissue. The implant will become exposed and, by definition, will be infected (Fig. 1a, b). The clinician must be careful to distinguish impending cylinder erosion of a benign nature caused by technical error from a cylinder that is eroding because of underlying infection. This is easy to do since an infected implant will have other signs of infection such as pain, redness, induration and even drainage (Fig. 1c).

If a cylinder is discovered eroded through the skin or urethra months or years after the original surgery (Fig. 1) the entire device must be removed due to contamination of the device. The bacteria that contaminate the exposed cylinder will enter from the perforation and wick along the interconnected components contaminating the entire device. These are generally wimpy skin bacteria, so the patient may not appear infected at time of presentation. Nevertheless, our experience in these cases has been that removal of only the offending cylinder is invariably complicated months later by demonstrable infection of the remaining components. Rarely, in a favorable setting without a toxic infection, partial salvage may be attempted with placement of a solitary malleable on the non-eroded side after extensive washout. **IMPORTANT:** Erosion of an IPP component equals infection and must be treated with removal of all device components regardless of

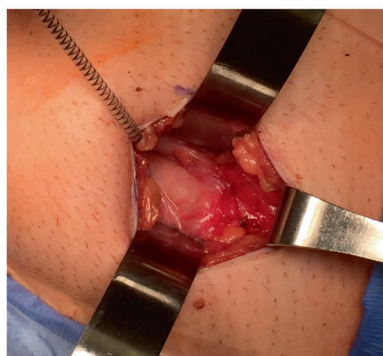
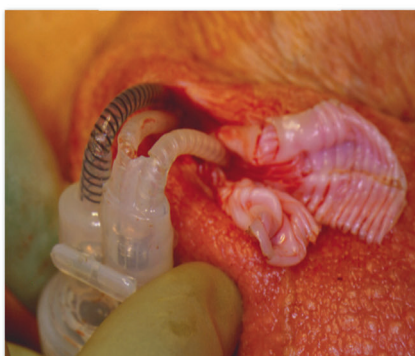
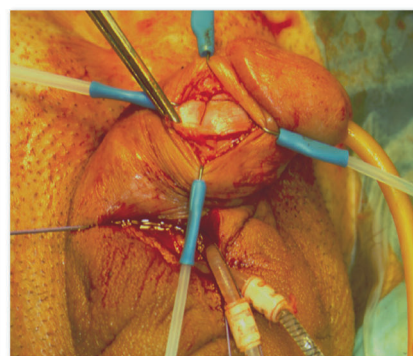
A. Reservoir capsule

B. Pump capsule

C. Cylinder capsule

**Fig. 2 Mulcahy's distal corporoplasty uses capsule.** **a** Reservoir capsule. **b** Pump capsule. **c** Cylinder capsule.

The repair was devised by Mulcahy in the late 90's and is still the gold standard for repairing impending cylinder erosion [1]. Even the occasional implanter can accomplish this repair if properly instructed in its technique. Mulcahy's distal corporoplasty uses two layers of the tough fibrous capsule (Fig. 2) that the body always creates to envelop implant components (read foreign body reaction). This repair with robust capsular tissue buttresses the cylinder tip and prevents repeat erosion. In our opinion, the repair is only suitable for inflatable cylinders. Mulcahy described the

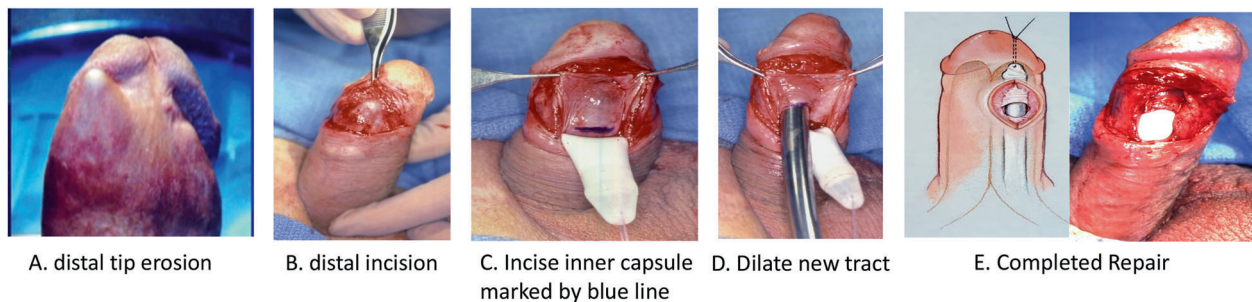
**Fig. 3 Original Mulcahy illustrations for distal corporoplasty.** **a** Distal tip erosion. **b** Distal incision. **c** Incise inner capsule marked by blue line. **d** Dilate new tract. **e** Completed repair.

The repair was originally described as only making an incision in the distal penis. The tunica and anterior capsule was incised, the cylinder deflated, and the cylinder tip removed from the capsular incision (Fig. 3a–c). The back wall of the capsule is then incised (Fig. 3c) and the scissors or dilator deployed to make a new resting place for the distal tip of the cylinder beneath the two layers of capsule (Fig. 3d). It is only necessary to dilate to 9 (the diameter of a Furlow) for insertion of any inflatable cylinder tips manufactured by Boston or Coloplast. The cylinder tip is then passed into the new tract with the Furlow insertion tool. If the same cylinder is to be used, a new guide suture can be created by passing a 00 Vicryl through the tip of the cylinder. The old erosion tract is obliterated by incorporating it in the corporotomy closure. When the repair is

If the cylinder is impinging on the glans or urethra one additional step is necessary. The distal aberrant tract of the capsule is closed with a purse string of non-absorbable suture as a “belt and suspender” adjunct (Fig. 4). Then the identical rerouting of the cylinder tip (Fig. 3a–e) described in the preceding paragraph is performed through the interior wall of capsule.

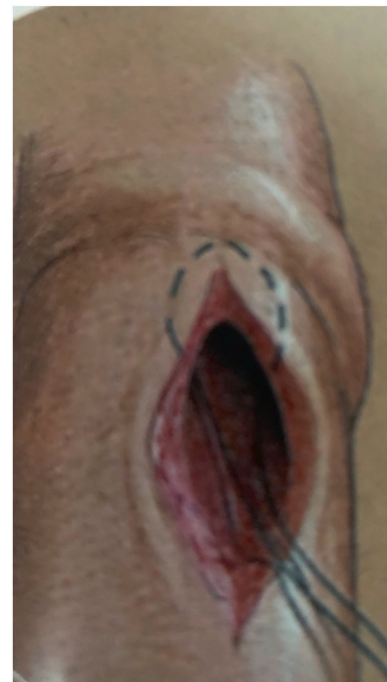
**Fig. 4** Additional suture if impending cylinder into urethra.

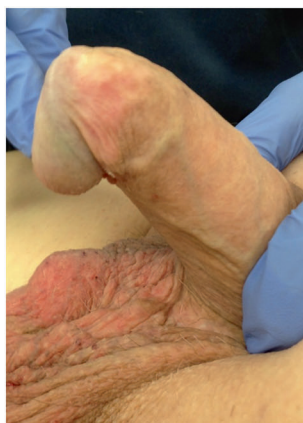
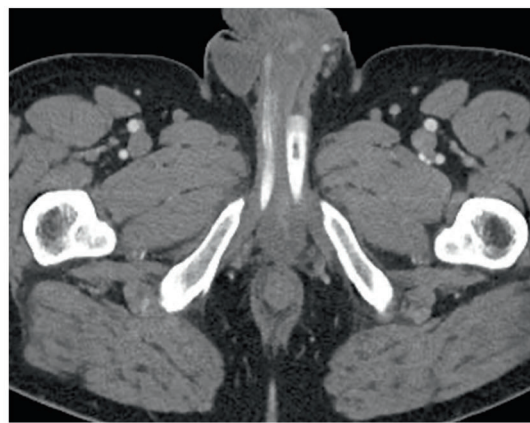
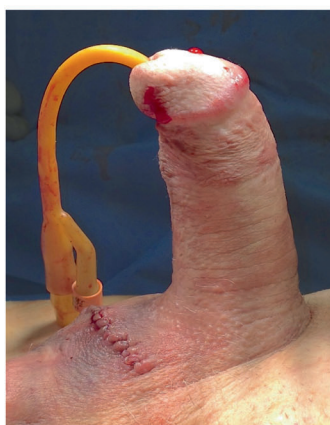
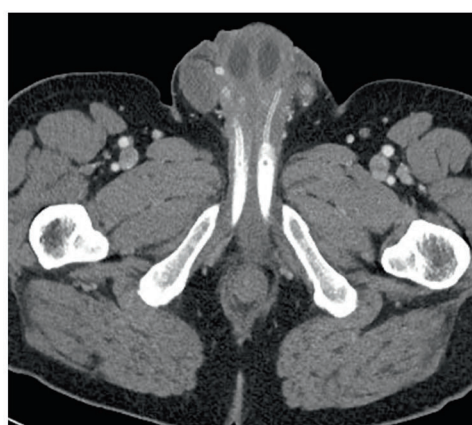
**Fig. 7 Pseudo SST from cylinders too short.** **a** Before: 16 cm cylinders & pseudo SST. **b** Before: Cylinders not in Crus. **c** Post op +5 cm: True corporal length 21 cm. **d** Post Op: cylinders deeper in proximal corpora.

**A. Before: 16cm cylinders & pseudo SST**

**B. Before: Cylinders not in Crus**

**C. Post op + 5cm: True corporal length 21cm**

**D. Post Op: cylinders deeper in proximal corpora**

An out of place proximal cylinder is very evident to the patient. His erection is diminished, his glans may be floppy with SST deformity (Fig. 7a) and/or the cylinder tip is

palpable in the shaft of the penis short of where it should be i.e., nestled beneath the glans. The etiology is either iatrogenic during the original implantation or weakened proximal corpora from corporal fibrosis and diminished blood supply which rupture with repetitive usage of the device (Fig. 7b).

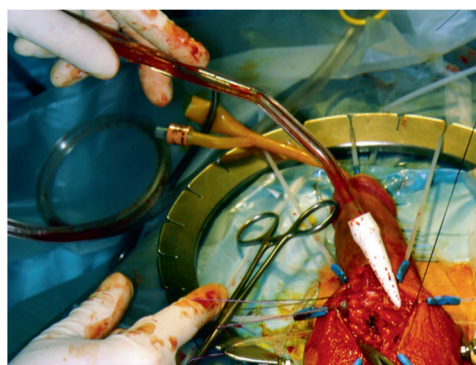
When RTE is lost, before instrument passage into corpus, fill with irrigation fluid and pass sucker tip to base

**Fig. 8 Retrieval of RTE with adult Yankauer suction tip.** When RTE is lost, before instrument passage into corpus, fill with irrigation fluid and pass sucker tip to base.

does not. Usually the RTE will appear stuck to the tip of the sucker upon withdrawal (Fig. 8).
